# When Compartmentation Fails: Real-World Consequences from Grenfell & Hong Kong

Shahid Malimar  
National Sales Manager

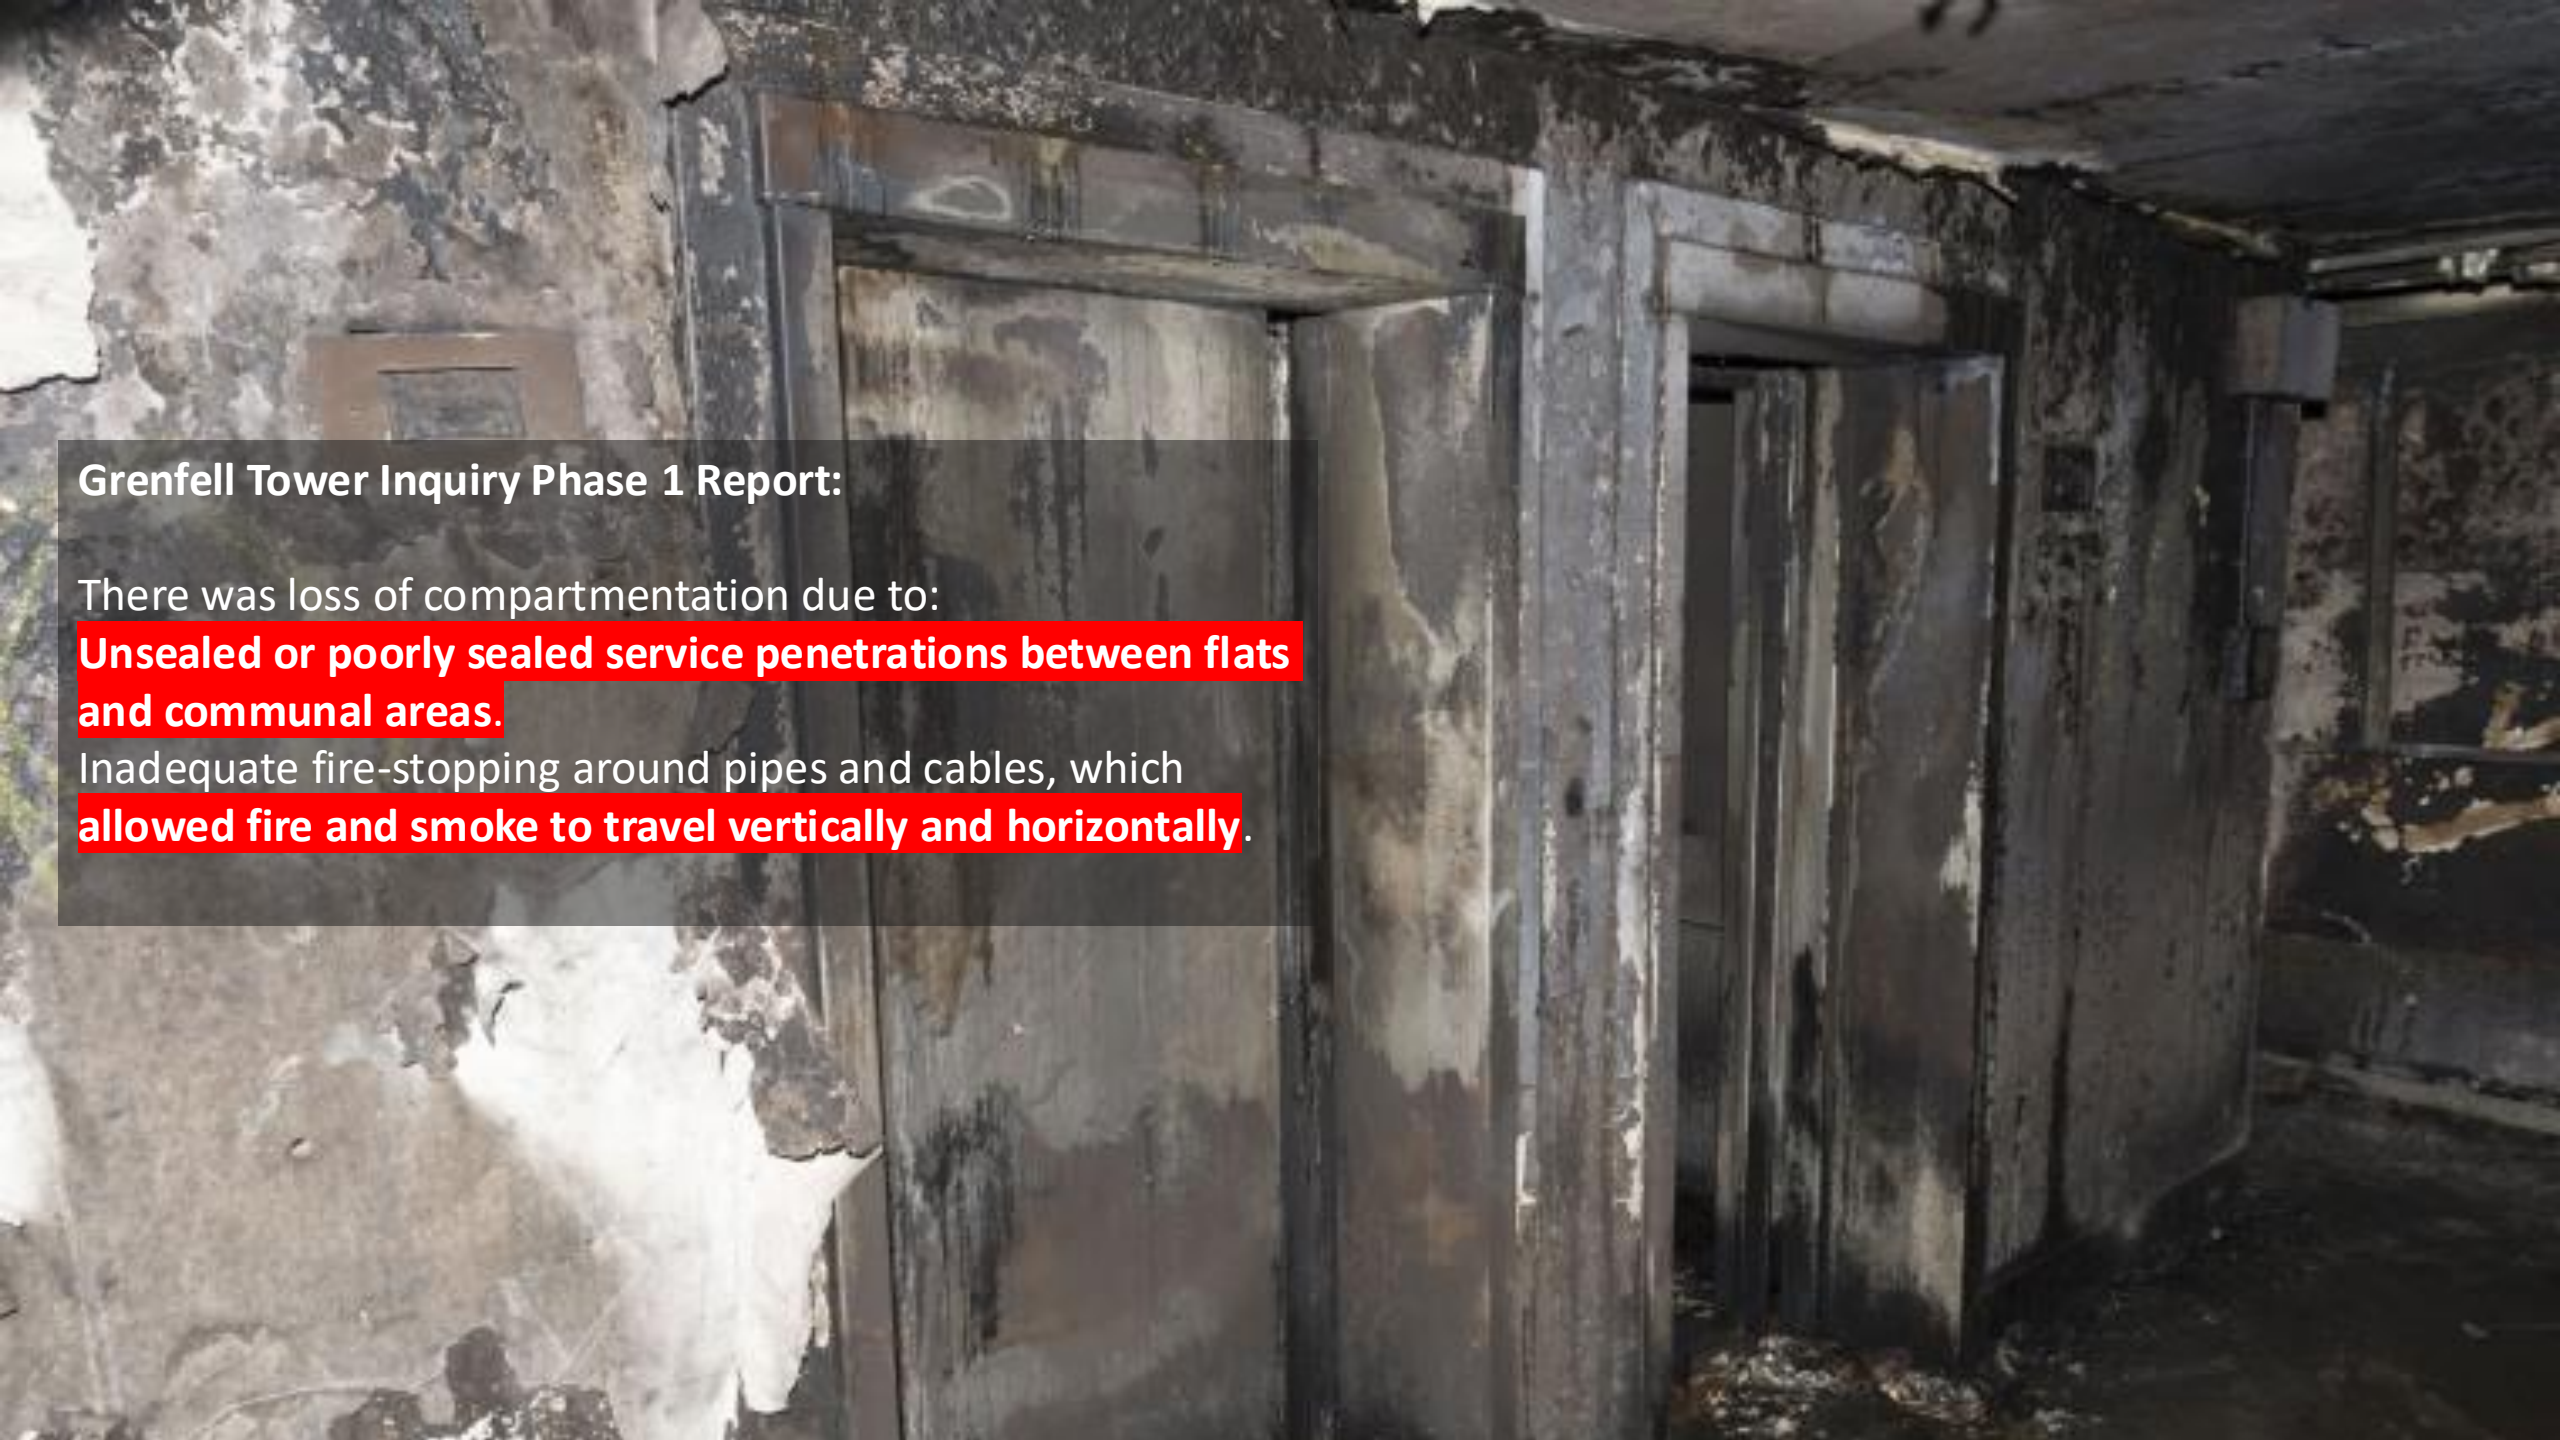
A photograph showing the interior of a building, likely Grenfell Tower, after a fire. The walls are heavily charred and peeling, revealing the underlying structure. Several doors are visible, some of which appear to be damaged or missing. The overall scene is one of significant destruction and disrepair.

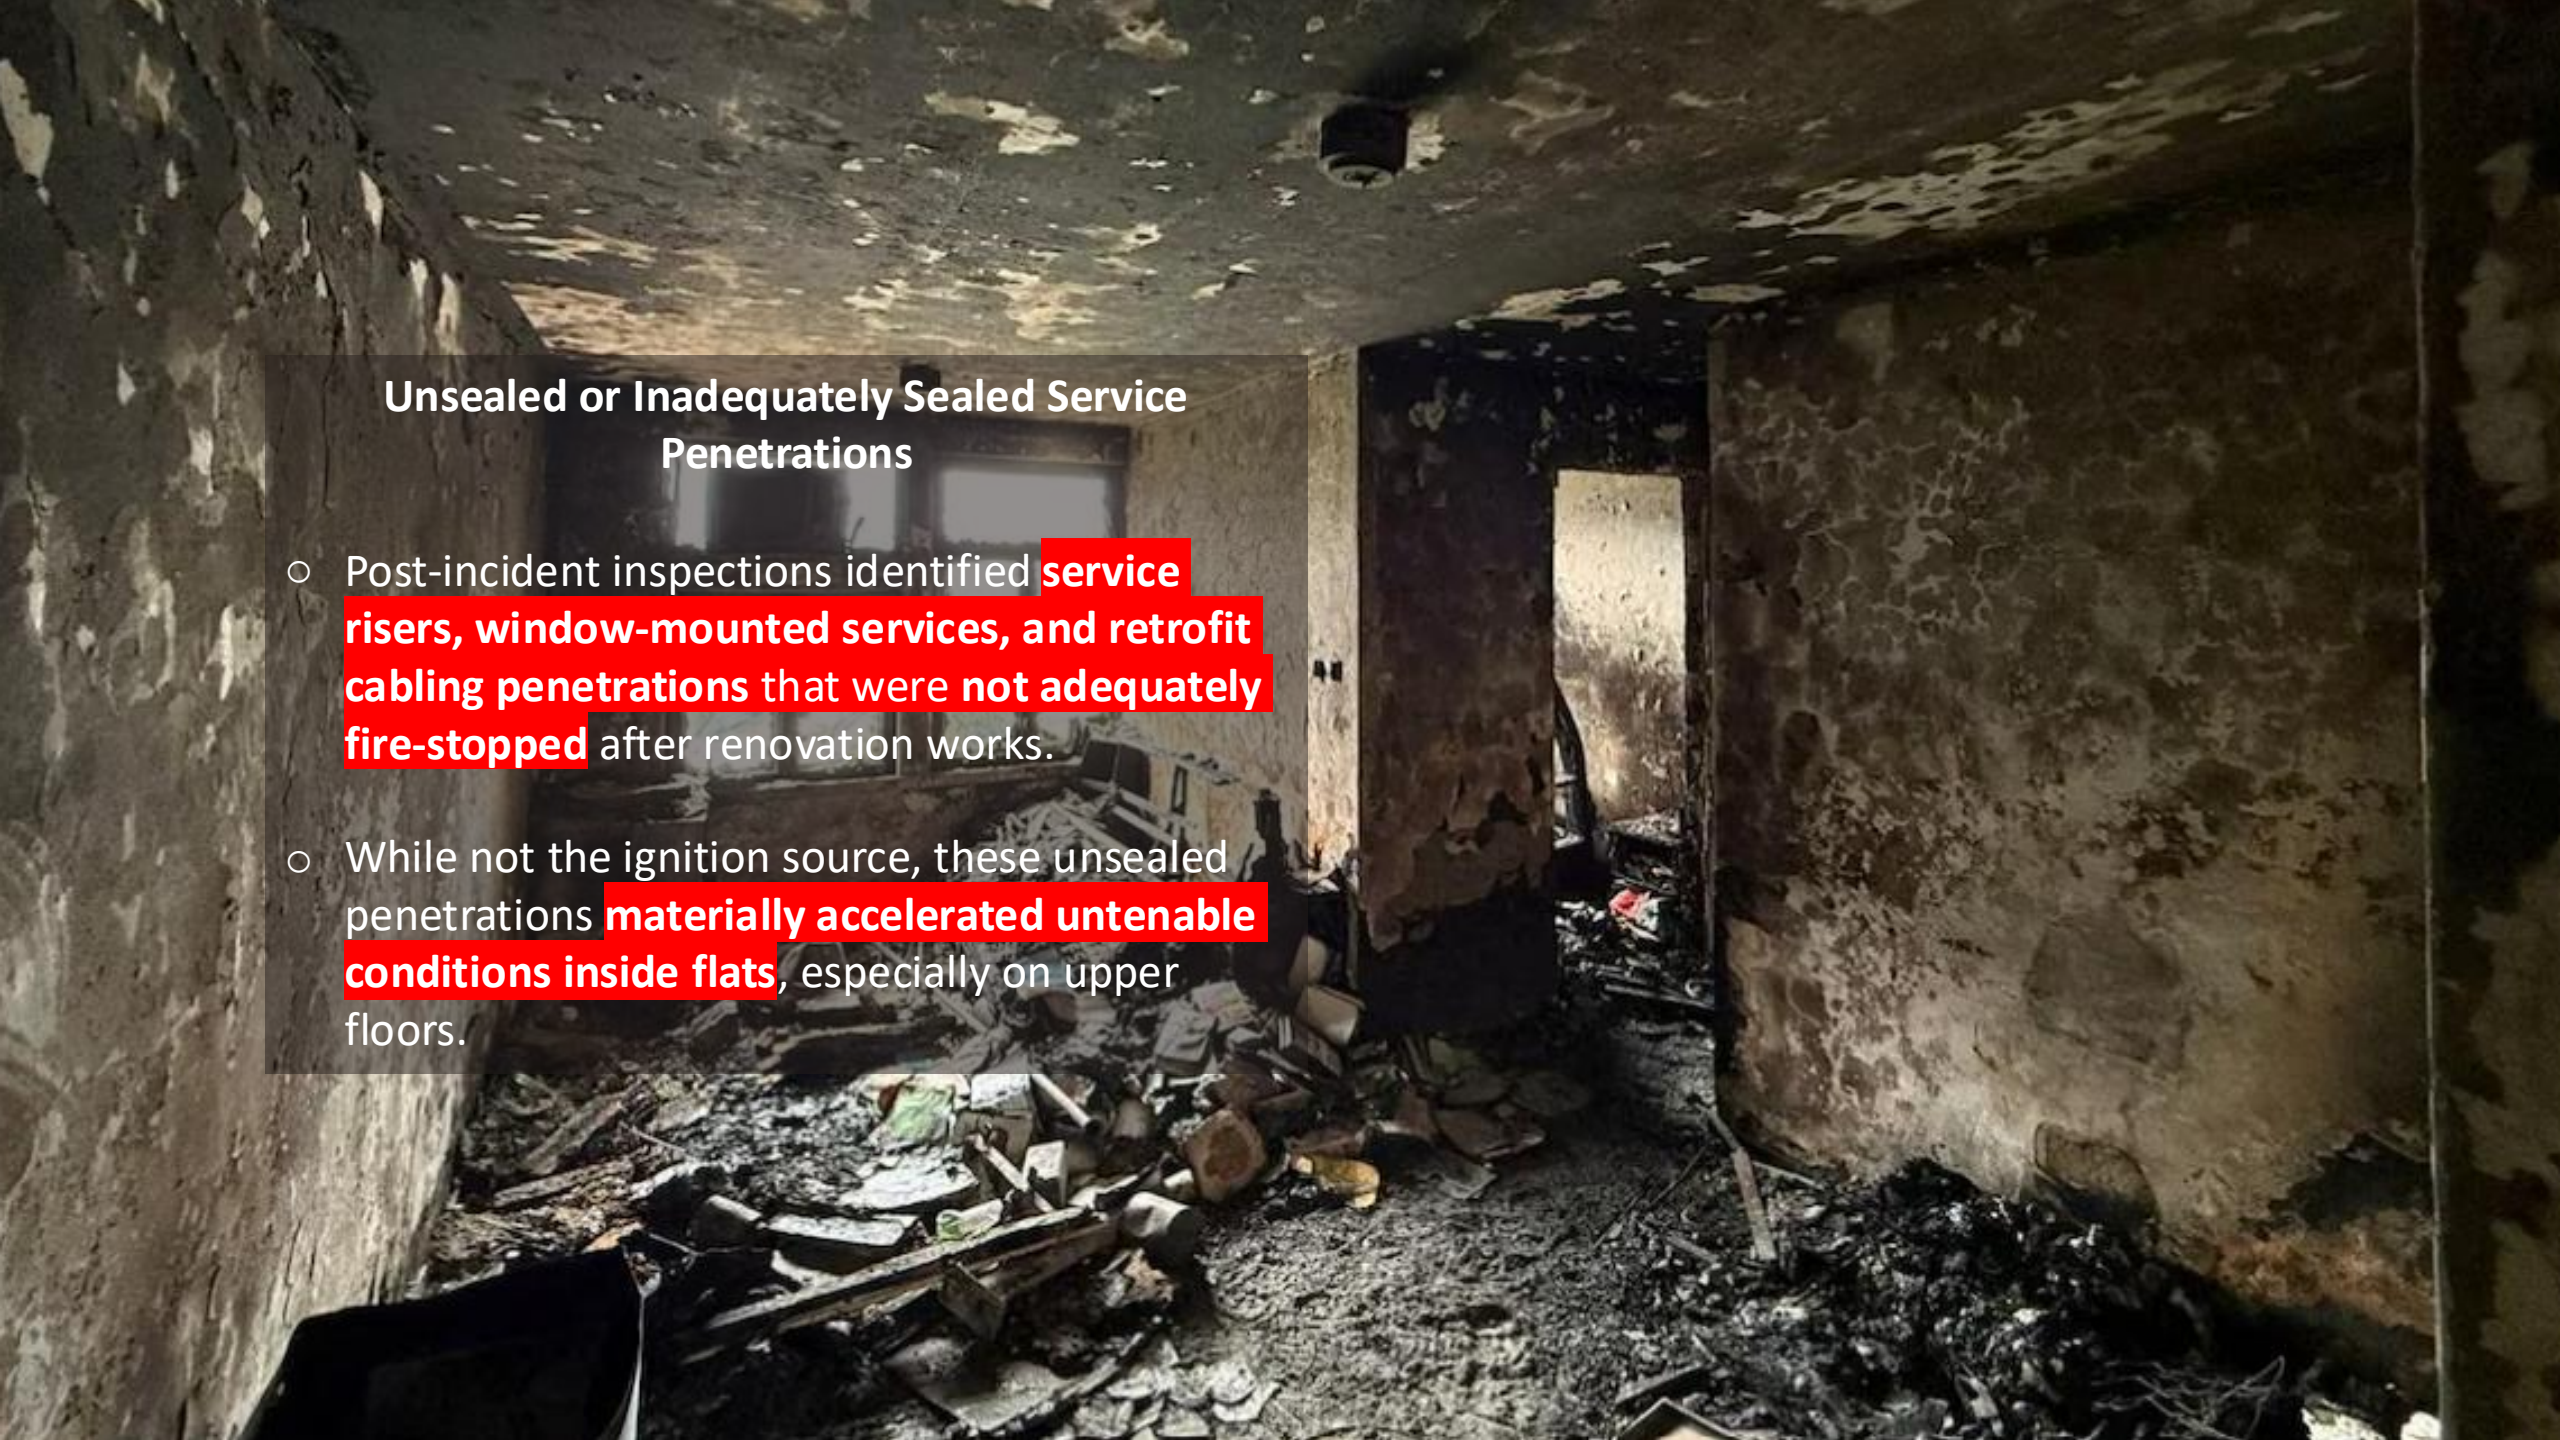
### Unsealed or Inadequately Sealed Service Penetrations

- Post-incident inspections identified **service risers, window-mounted services, and retrofit cabling penetrations** that were not adequately **fire-stopped** after renovation works.
- While not the ignition source, these unsealed penetrations **materially accelerated untenable conditions inside flats**, especially on upper floors.

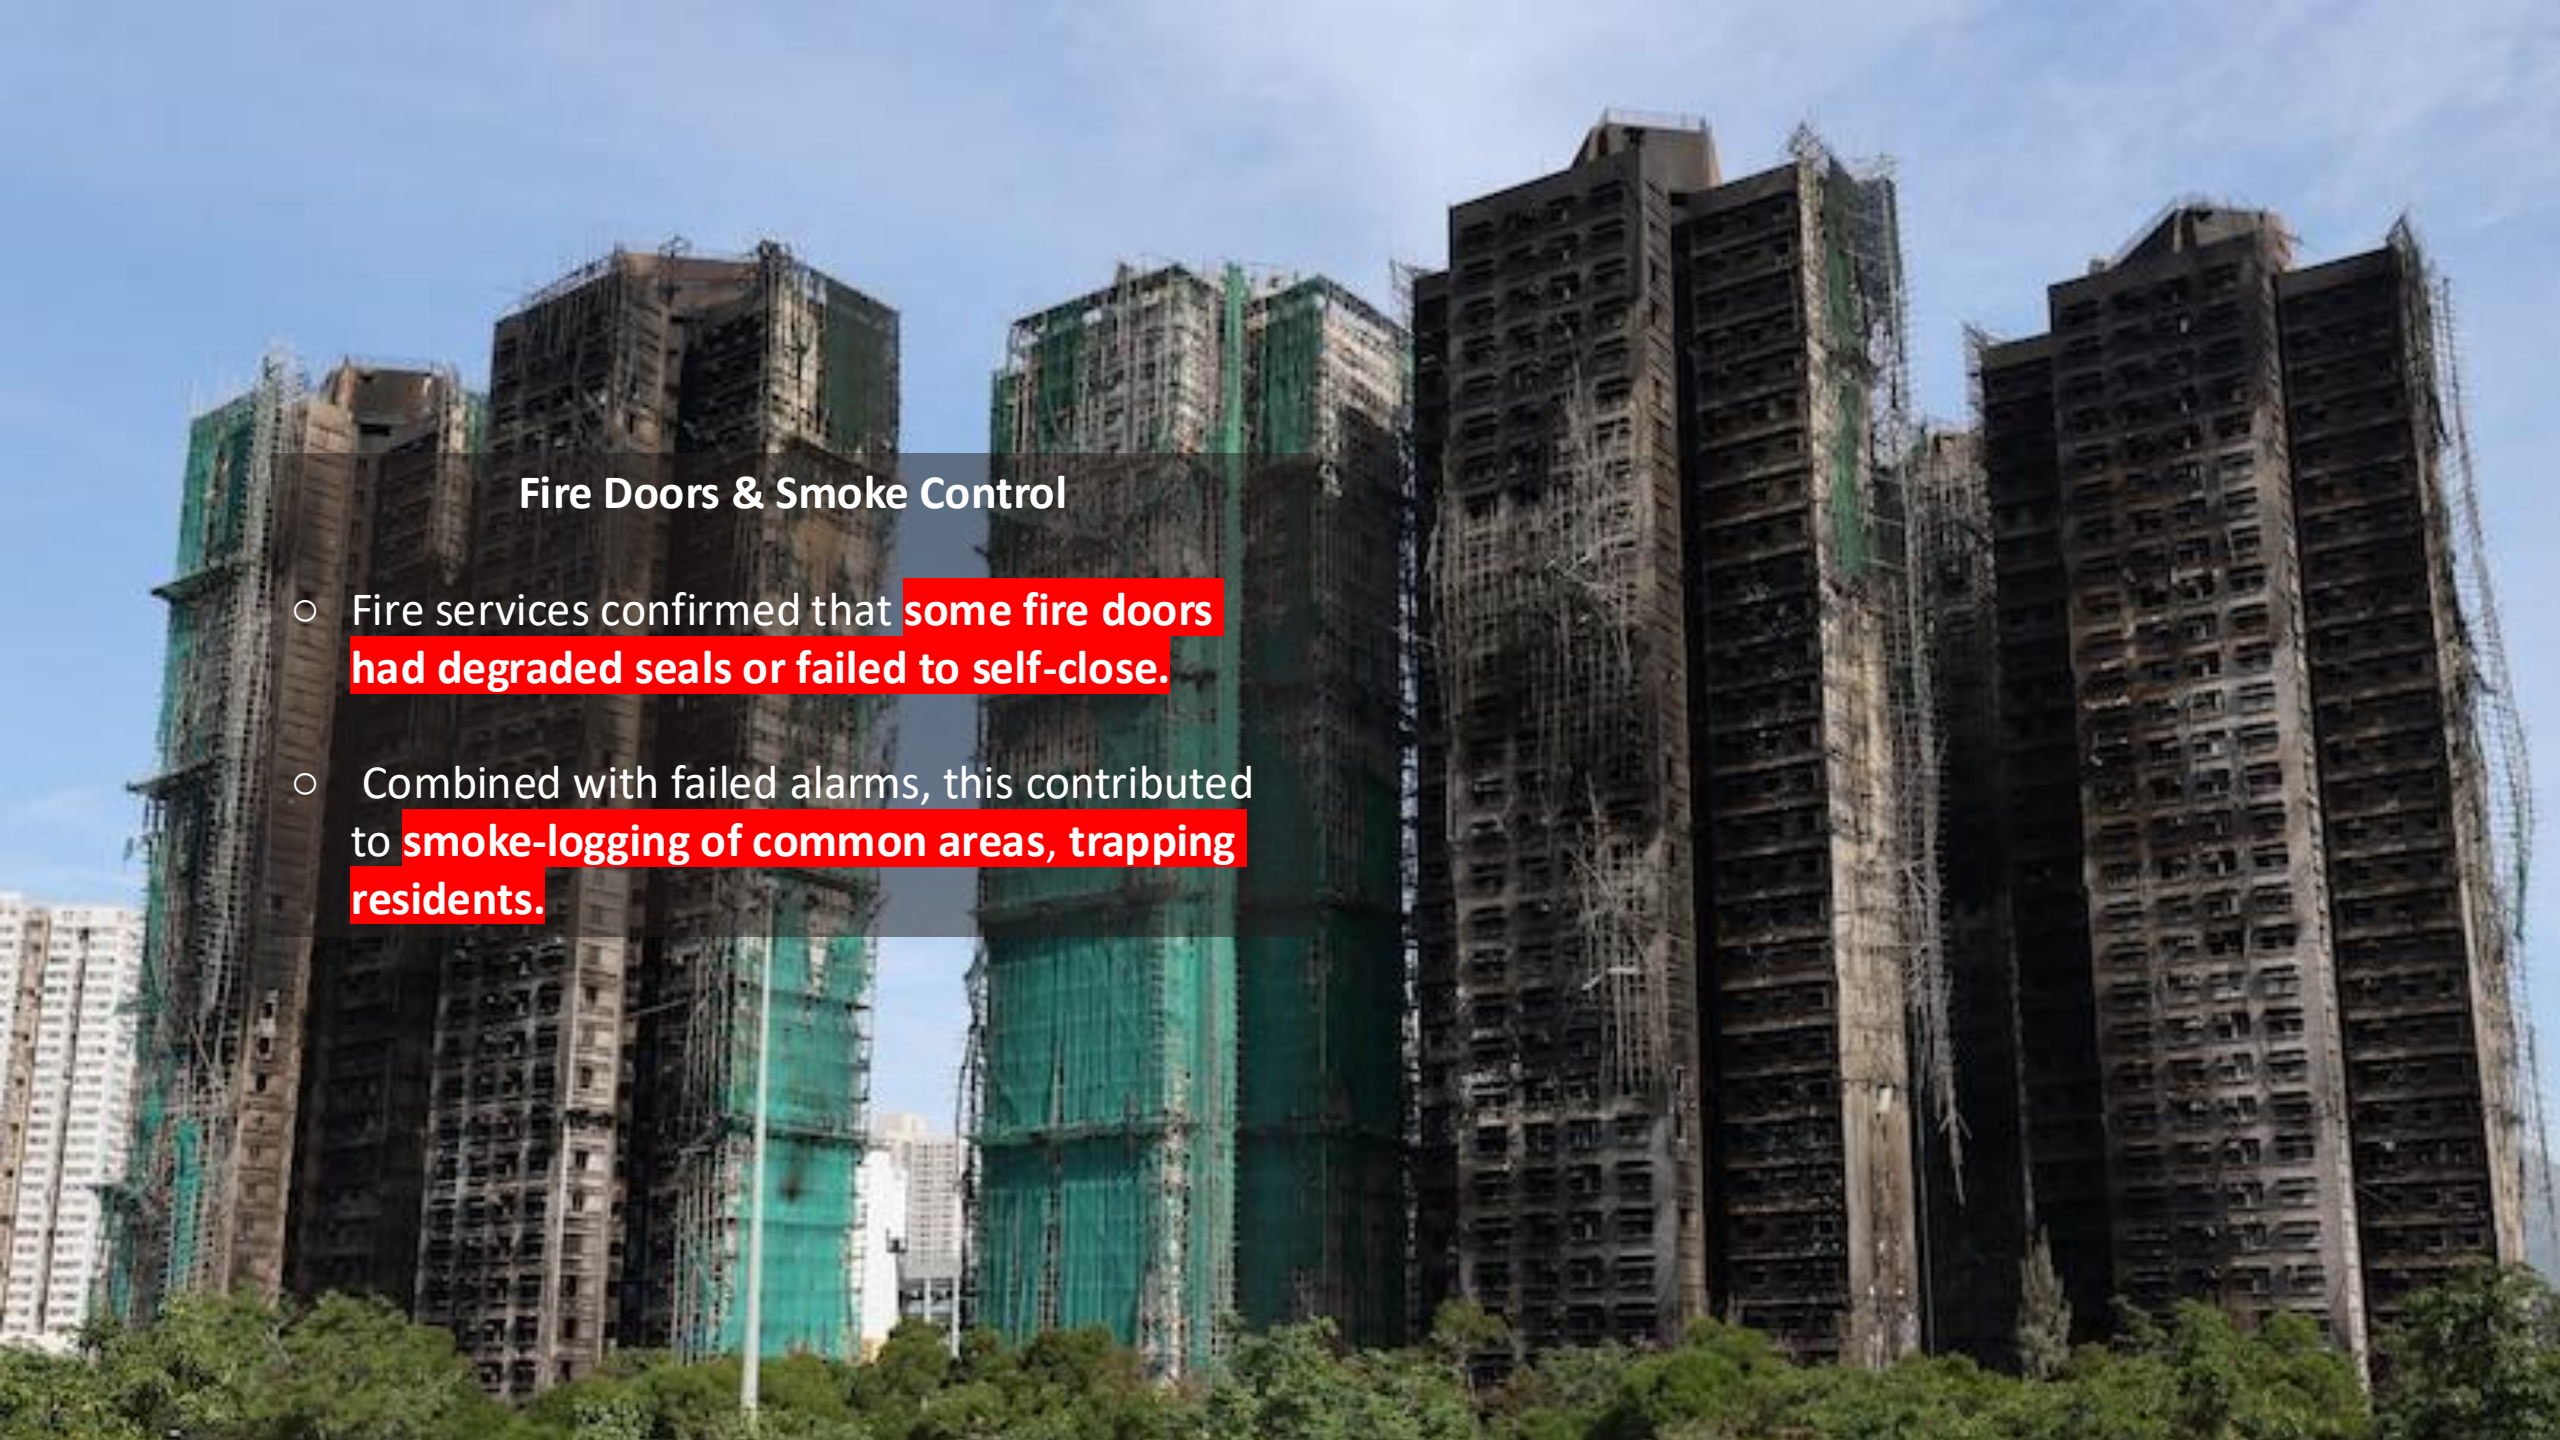
### Façade Cavity & Edge-of-Slab Failures

- Continuous bamboo scaffolding and netting created a **chimney effect**, but investigators also noted **insufficient cavity barriers and edge-of-slab fire seals** once façade elements were temporarily dismantled.
- This allowed **fire to leap vertically floor-to-floor**, bypassing slab-to-slab fire separation intended to arrest vertical spread

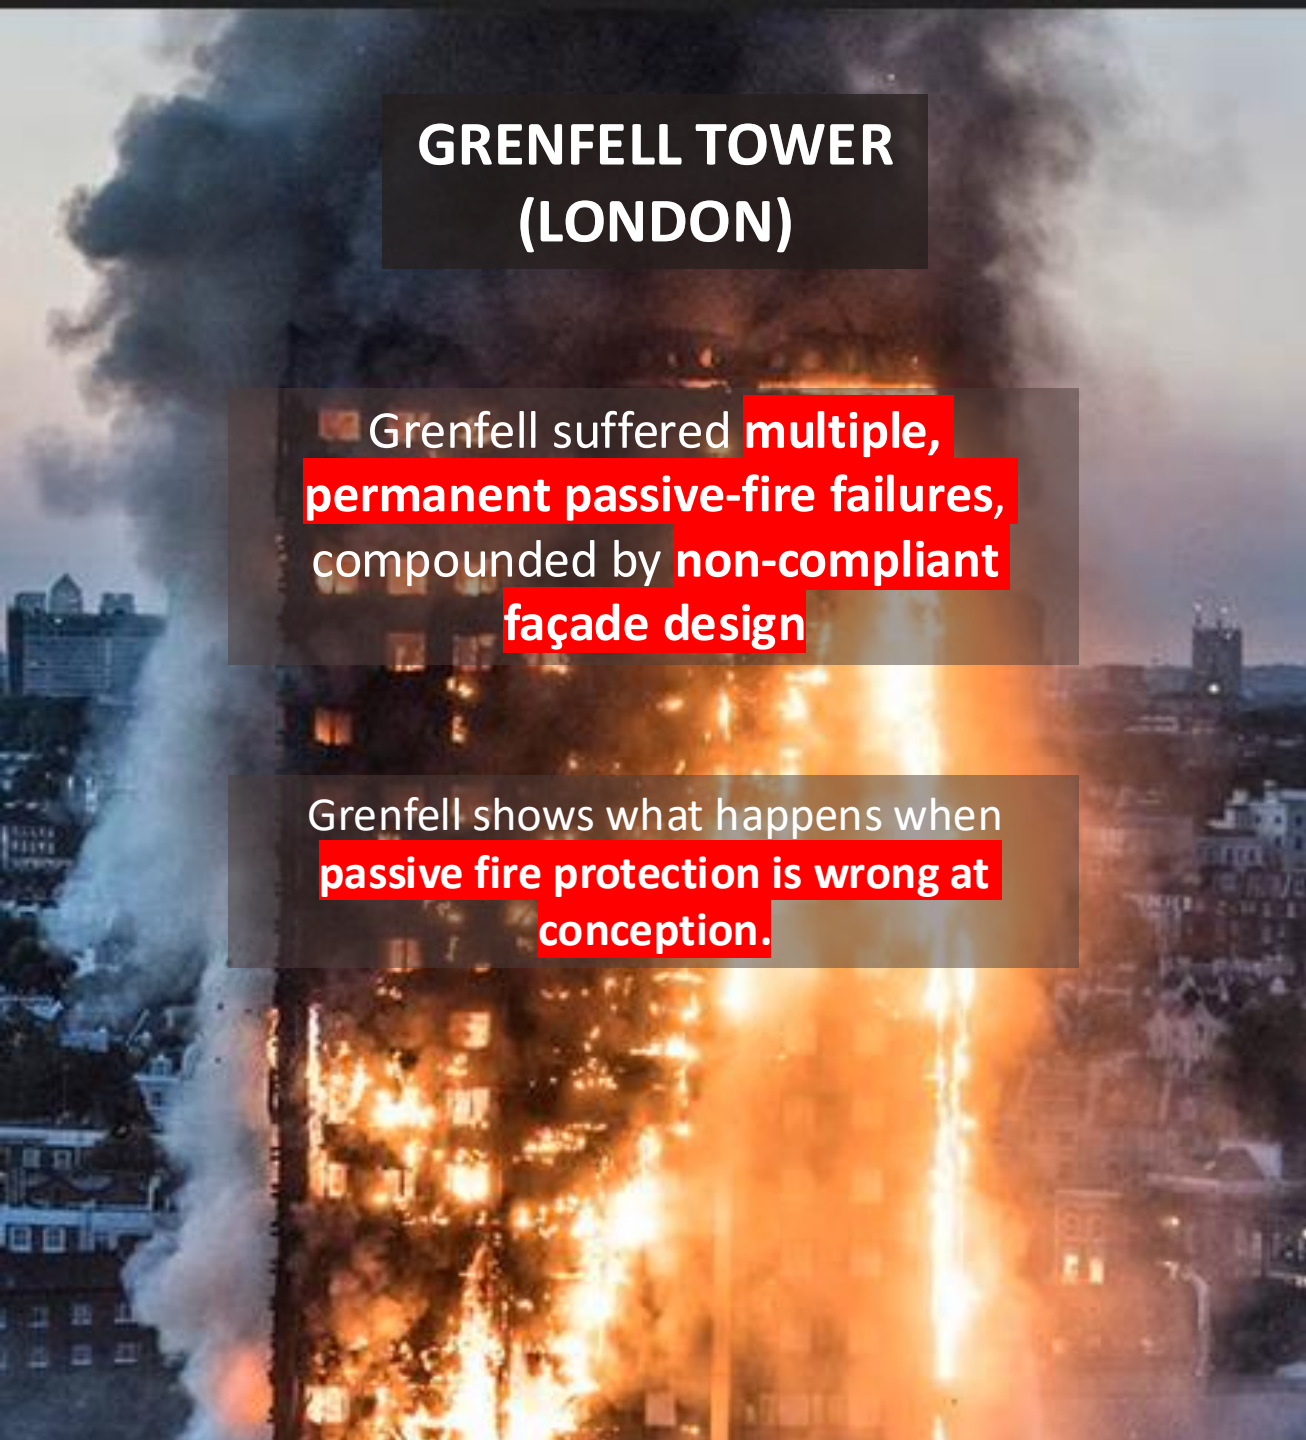
## GRENFELL TOWER (LONDON)

A photograph of the Grenfell Tower in London during a major fire. Thick black smoke billows from the top of the building, and bright orange flames are visible at the base and in some windows. The surrounding city is visible in the background.

Grenfell suffered **multiple, permanent passive-fire failures**, compounded by **non-compliant façade design**.

Grenfell shows what happens when **passive fire protection is wrong at conception.**

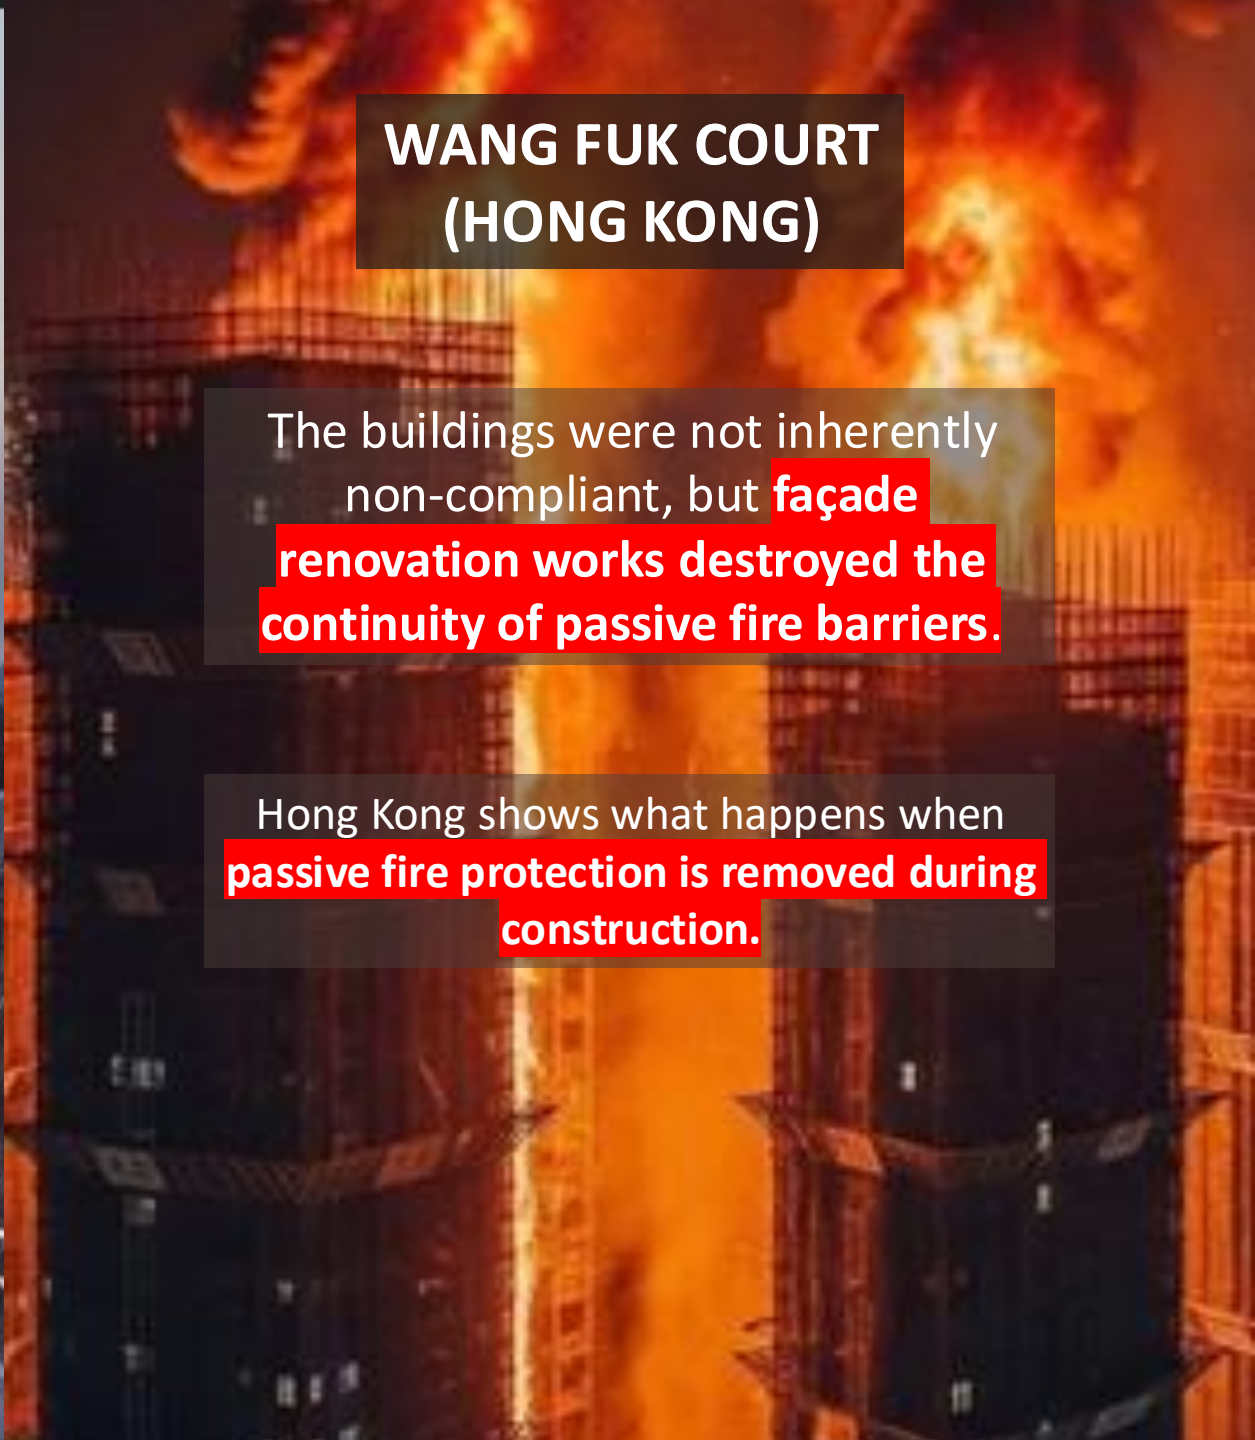
## WANG FUK COURT (HONG KONG)

A photograph of the Wang Fuk Court in Hong Kong during a major fire. The building is completely engulfed in intense orange and yellow flames, with fire visible through the windows and from the top. The surrounding area is dark, and the fire is the central focus.

The buildings were not inherently non-compliant, but **façade renovation works destroyed the continuity of passive fire barriers.**

Hong Kong shows what happens when **passive fire protection is removed during construction.**
